Capital Improvement Projects

DECEMBER 8, 2024

HOLY FACE OF JESUS
PARISH

The Four Upcoming Projects

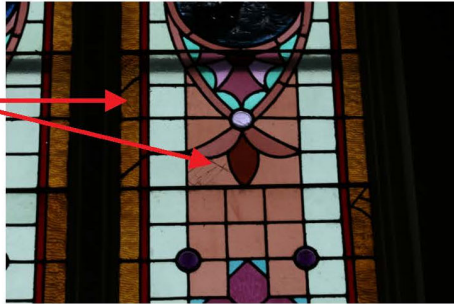
Diagram B

This panel has an extensive amount of broken glass. This is a problem throughout the church.

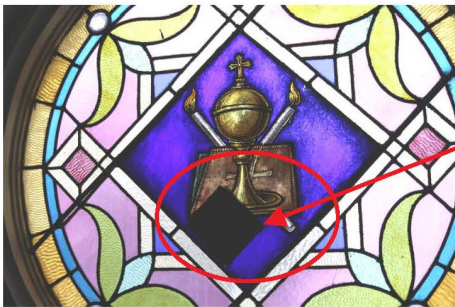
This symbol has a large hole and is covered by a piece of metal.

- All the pieces of stained glass will be cleaned and matched.
- The lead and frames will be replaced
- To refurbish all 18 windows, it will cost \$169,000

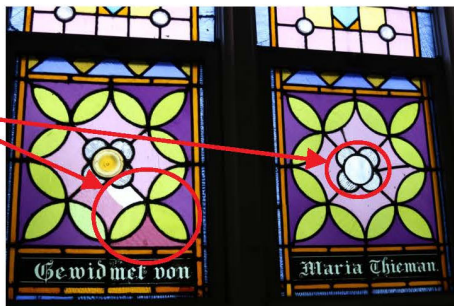
There are many panels that have broken and mismatched glass throughout the church. This is the opportune time to replace the glass in these areas.

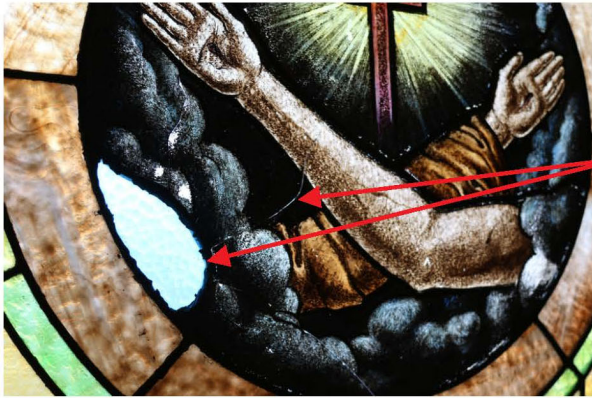
Here is a symbol that has been broken for some time. We will replace this with a new symbol using our progressive painting system where we can digitally re-master the piece for the most accurate duplication.

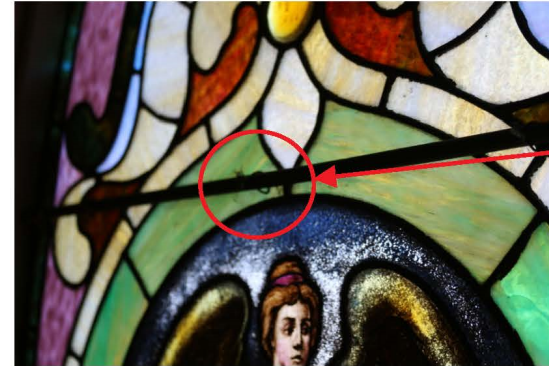
Numerous areas around the church have broken tie wires. Once these tie wires break away from the stained glass, the windows begin to bow at an accelerated pace. This eventually leads to glass breakage. We recommend restoring your windows before this becomes a more expensive repair in the future.

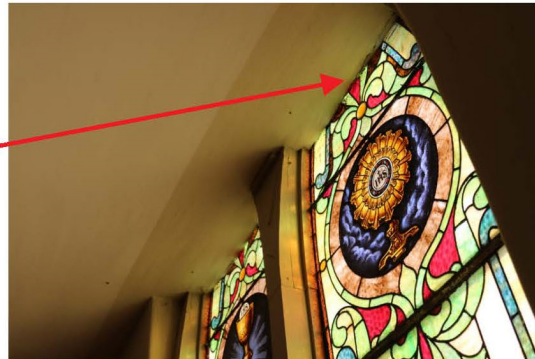
This window runs through the ceiling into the attic. We will cut the plaster back for the windows removal. We prefer the church call in a local drywall/plaster contractor to repair this area after the restoration is complete. Any plaster work that you want us to complete will be an additional cost.

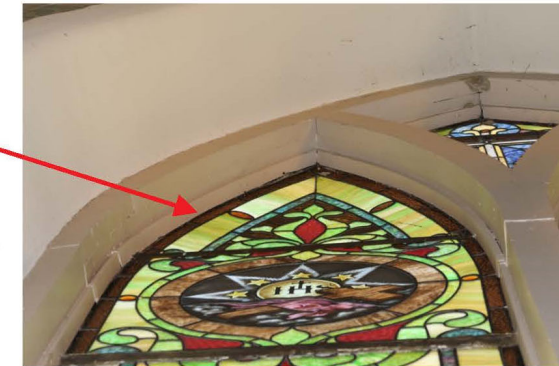
If you look closely at a few of your windows, you will see that some have begun to bow. This is due to the fact that the lead, solder, and cement are in a deteriorated state.

We will be completely dis-assembling your windows and replacing the lead, solder, and cement with new. This will bring your windows back to their original strength, before any more damage can occur.

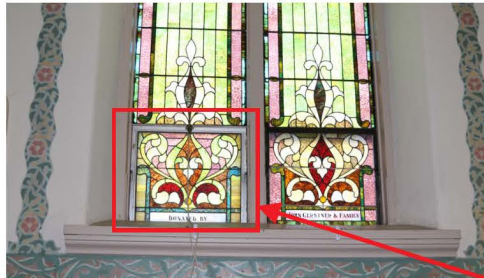
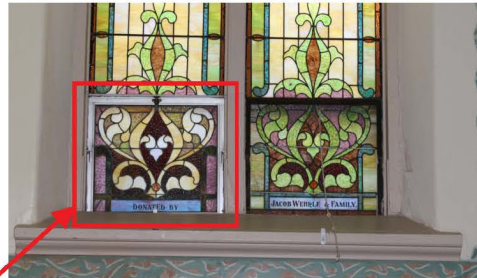
These two ventilators have been placed in the wrong location years ago when the ventilators were updated. We will be swapping these two ventilators back when the restoration is being completed.

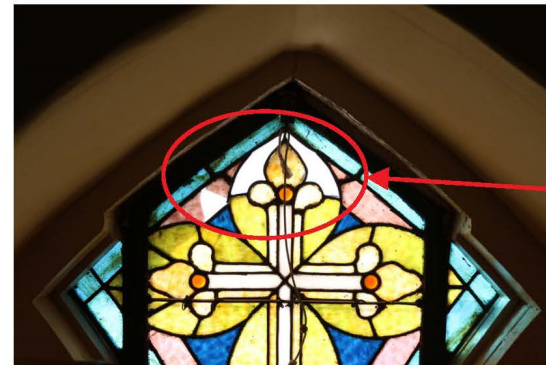
Some stained glass has already broken and fallen out as seen here. We will need to look for glass matches and replace areas like these.

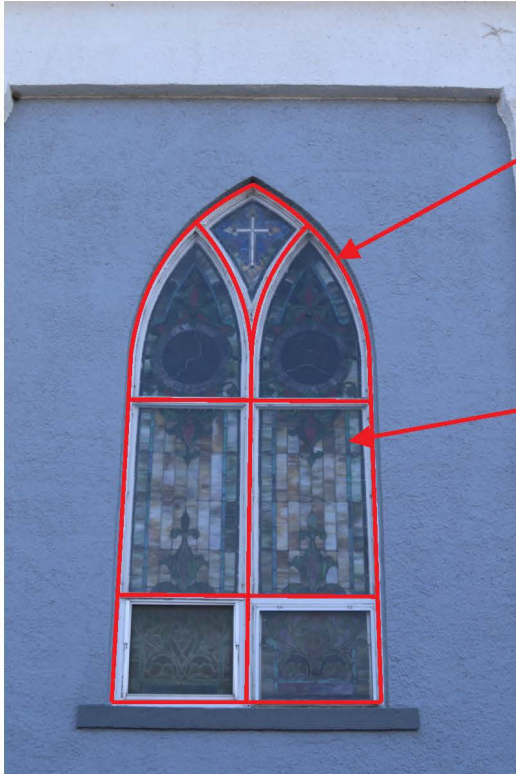
To the left is our proposed frame layout for your rose window. Our intent is to protect the window as a whole, without taking away from the overall appearance.

Final T-bar placement will be determined by our exterior site crews after taking actual field measurements.

Your current storm glass system is comprised of poly-carbonate coverings and do not have any venting. Poly-carbonates flex under wind loads and have a negative impact on your stained glass windows.

We will be installing our custom aluminum frames on your church that incorporate special venting T-bars and 1/4" clear plate glass. The 1/4" plate glass is much stronger and can handle the wind loads, as well as having a much better cosmetic appeal. Our new aluminum frames will then cover over the existing wood for a relatively maintenance free exterior. At this point, the ventilators will no longer be operable.

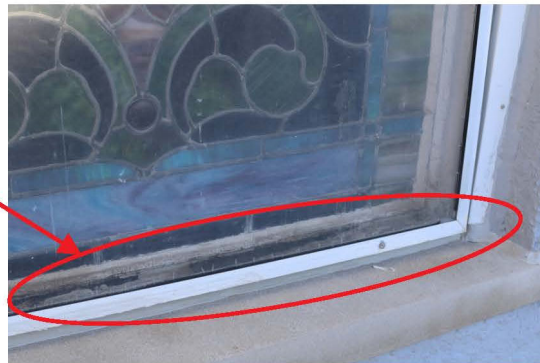
Some of your wood has not been maintained as seen here and will need to be replaced. When we find rotten wood, our crews will fix these areas on a time and materials basis.

We use mahogany wood for all exterior wood repairs due to its resistance to rot and termites.
